LUXEON[®] Reliability

LUXEON[®] Power Light Sources represent a revolutionary advance over conventional small signal LED light sources. This application note summarizes the reliability performance of the LUXEON family. The application note discusses general reliability concepts, potential failure modes, and aspects of product reliability that are affected by the customer application.

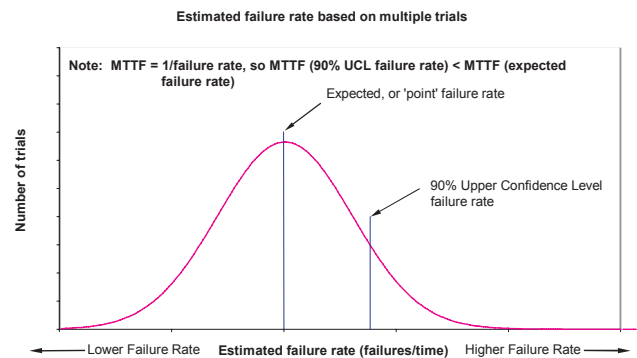
Figure 5a. Relationship between expected or ‘point’ failure rate and 90% UCL failure rate.

The ‘90% upper confidence limit (abbreviated as UCL) for failure rate’ is defined as the failure rate given that there is a 90% probability that the actual failure rate will be as good or better than the value predicted, based on an assumed

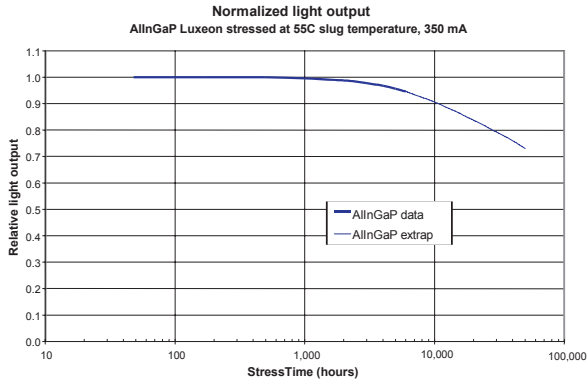
Figure 6.

Figure 6 shows lumen maintenance data for the AllnGaP LUXEON stressed at 350 mA at 55°C slug temperature (71°C junction temperature). (Note: in these reliability stress tests, the LUXEON is mounted to a thermally-controlled plate such that the temperature at the underside of the heat-sink slug is maintained at a fixed temperature, which in this text is referred to as the slug temperature). Note that the change in light output is expected to be about -9% after 10,000 hours.

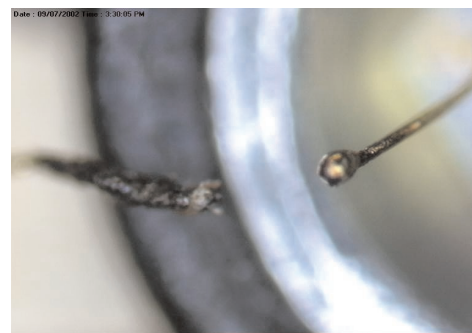
High-energy electrical transients/currents can also damage the LUXEON package. Under extreme high currents, the gold wire acts as a fuse. Figure 17 shows a typical fused-wire catastrophic failure.

Figure 17. Fused wire failure.

Note that the fusing current depends on the amplitude and duration of the electrical transient as well as the diameter of the gold wire. Finally, note that electrical transients with very long pulse duration as well as excessive dc forward current can also cause various types of thermal overstress failures, which are covered in the thermal overstress section.
